Decoding the Façade: A Practical Workflow for Inspecting Window and Railing Systems in High-Rise Construction

Atul Prakash Lad
Project Engineer, CMC Construction, Inc., Miami, Florida, USA.

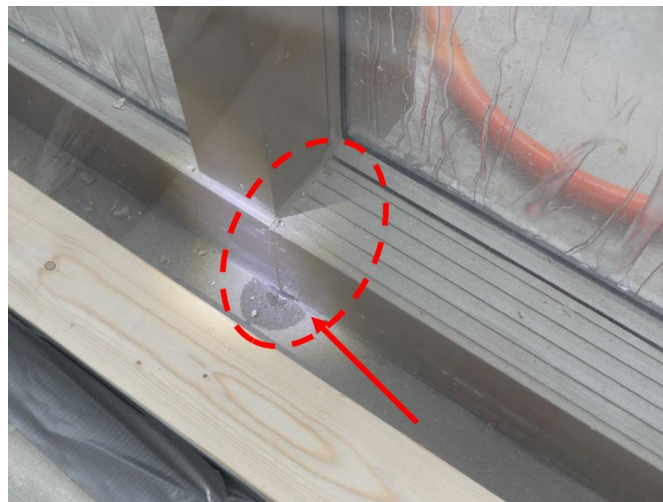
A test is considered a pass if no uncontrolled water penetrates beyond the interior plane of the frame or bypasses the intended drainage path [4], [5]. Any measurable leakage into the occupied side is treated as a failure and triggers a root-cause investigation of glazing gaskets, frame joints, anchor penetrations, or sealant terminations.

Fig 10: Water Intrusion at Sliding Glass Door Sill, with Leakage Migrating Beyond the Interior Plane of the Frame (Failure Condition).

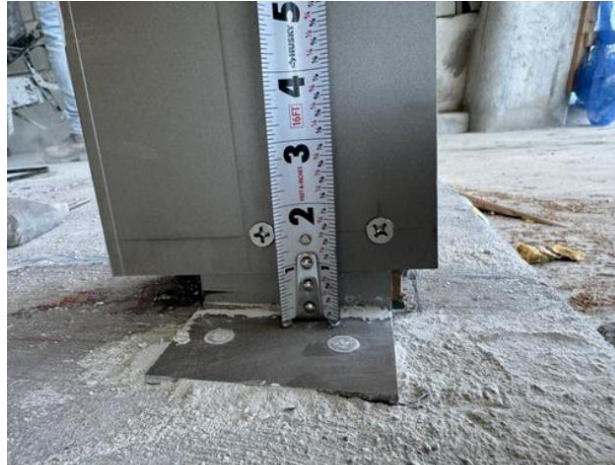
Two recurring technical issues dominate this category. The first is insufficient clip engagement or edge distance. In a typical entry, the inspector notes that “insufficient clip engagement was observed at one opening” and refers to the shop-drawing limit of 1-3/16 in from the clip fastener to the edge of the aluminum tube. The accompanying photo shows a tape reading closer to about 1-9/16 in from tube edge to screw, so the as-built condition sits outside the tested geometry even though the frame looks finished. This pattern appears in several reports and becomes the most common mullion-related finding in the log.

Clip engagement distance of up to 1 9/16”.

Fig 11: Mullion Clip Edge-Distance Out of Tolerance, with Measured Clip Fastener-to-Tube Edge Distance of Approximately 1-9/16 In.

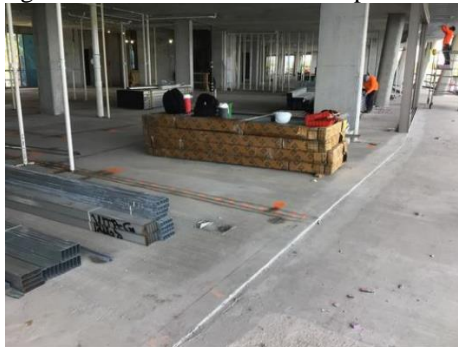
A third theme in the mullion-clip reports is “mullion not installed / incomplete opening.” In those cases, hoists, scaffolding, or other trades blocked installation at the time of the visit. The log still records these openings under mullion-clip inspections, but clearly as incomplete work or sequencing items rather than workmanship defects.

Mullion observed not installed.

Fig 12: Incomplete Opening at Time of Inspection: Mullion not installed Due to Ongoing Work and access Constraints (Sequencing Item, Not a Workmanship Defect).

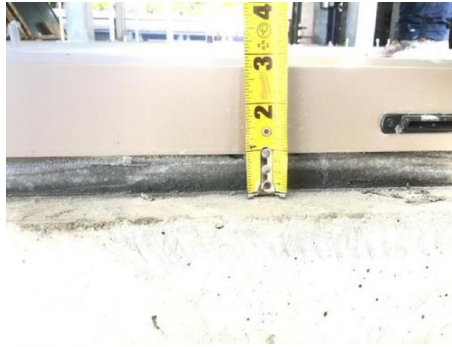
The dominant issue in this group is shimming. Multiple entries describe “excessive shimming” at balcony sills and railing shoes, including one case where shim stacks under a sill approached about 1 in in total height. Other photos show shoes sitting on a visible stack of plastic shims rather than a thin, uniform bearing layer. At the opposite end, some openings are recorded as having “no shims at shoe,” with a clear gap visible between the aluminum extrusion and the concrete support.

Excessive shimming up to 1" at sill.

Fig 13: Excessive Sill Shimming Observed at a Balcony Opening, with Shim Stack Height Approaching 1 In.

From the inspector's perspective, these findings are important because shims form part of the load path between aluminum and concrete. Tall stacks or missing pieces are treated as structural observations, not cosmetic notes, and the log reflects this by giving them their own descriptive entries.

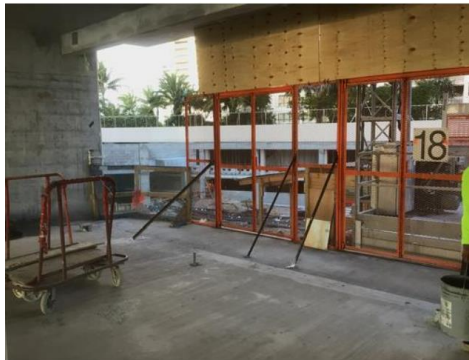
A second set of entries in this category simply notes "opening not installed at time of inspection." These lines document inspection attempts that encountered incomplete work, where frames or shoes were not yet in place. They are carried forward in the log so those locations can be revisited, but they represent progress and sequencing rather than non-compliance.

Not installed. Buck hoist.

Fig 14: Opening Not Installed at Time of Inspection Due to Buck/Hoist Staging; Noted as Sequencing (Not A Workmanship Defect)

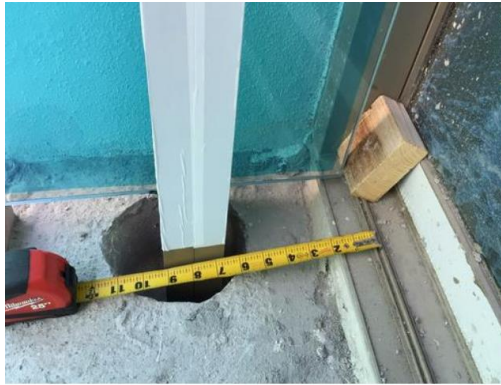
Three recurring issues stand out. The first is railing distance to sliding glass doors. Several entries state that the "railing distance to SGD not adequate to protect glass integrity." Inspection photos show a tape measure from the sliding glass door

frame to the first railing glass panel or post, with a relatively small clearance. The concern recorded in the log is that door operation or furniture movement could bring impact too close to the glass edge.

Railing distance to opening not adequate.

Fig 15: Insufficient Clearance between the Sliding Glass Door Frame and the Adjacent Railing Glass/Post, Creating an Impact Risk During Door Operation.

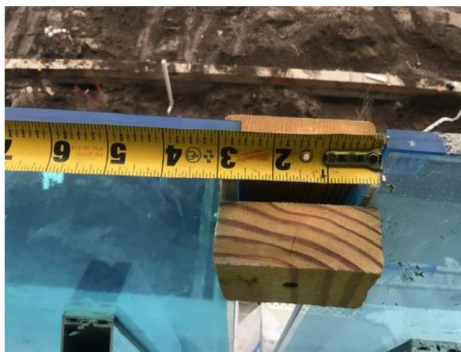
The second is excessive gap at expansion joints between railing runs. In one documented case, the gap between two adjacent railing panels measures up to about 2 5/8 in where the shop drawings limited that joint to 2 in. The photo shows a timber spacer and tape measure illustrating the gap. While still below the 4 in clear-opening limit used in many guardrail codes, this difference is large enough to be treated as an out-of-tolerance condition at a critical location [1]-[3].

Excessive gap between railings up to 2-5/8".

Fig 16: Expansion-Joint Gap between Adjacent Railing Glass Panels Measured at Approximately 2-5/8 In., Exceeding the 2 in. Shop-Drawing Limit.

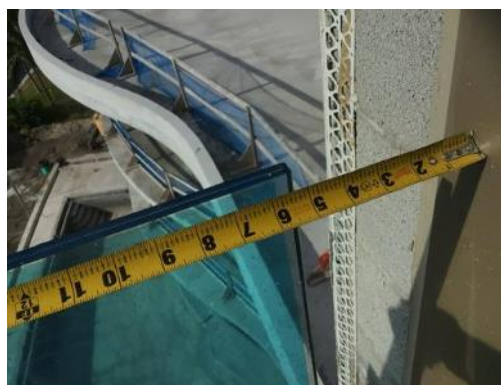
The third issue is excessive gap between railing glass and CMU walls. A series of reports note that the “distance to CMU not adequate. Max 2 1/2 in per shop drawings.” Tapes in the photos show measured clearances beyond that limit where the last piece of railing glass terminates at a shear wall. These entries highlight end conditions where as-built geometry does not match the intended closure to the wall and pushes the assembly closer to the guard opening limit.

Distance to CMU not adequate. Max 2-1/2" Shop drawings.

Fig 17: End-Condition Clearance between Railing Glass and Adjacent CMU Wall Exceeds the 2-1/2 In. Maximum Shown in the Shop Drawings.

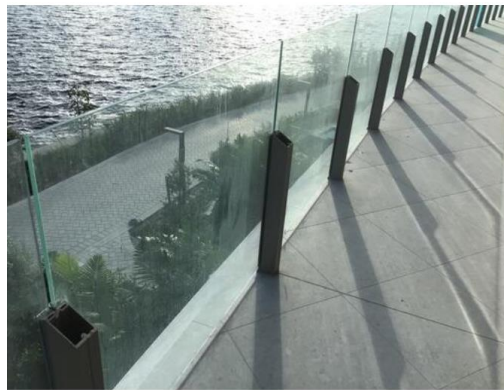
In the same area, inspectors also log missing railing post caps. Photos show finished balcony edges where several posts are still open at the top, with comments that caps are missing or not installed. Even when these are treated as punch-list items, the log text emphasises that open posts create a path for water and debris into the tube and are therefore relevant for long-term durability.

Missing caps.

Fig 18: Missing Railing Post Caps Observed Along Completed Glass Guard Line, Leaving Hollow Post Tubes Open to Water and Debris Ingress

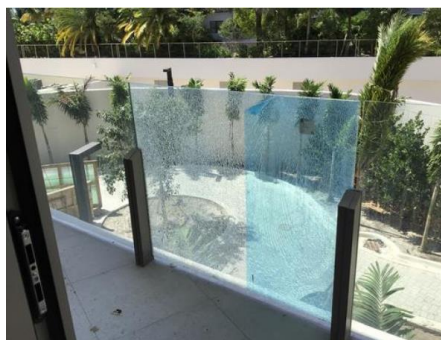
By the time close-out is reached, the log counts approximately 72 broken laminated balcony glass panels. The causes are varied and usually recorded qualitatively: damage during railing installation, accidental impact during balcony stone or tile work, and incidental contact from other trades moving tools and materials near the railing line. Each broken panel is noted with its location, report number, and a brief description.

Railing glass observed broken.

Fig 19: Broken Laminated Glass Panel Observed at Balcony Railing, Recorded for Replacement and Tracked in Inspection Log

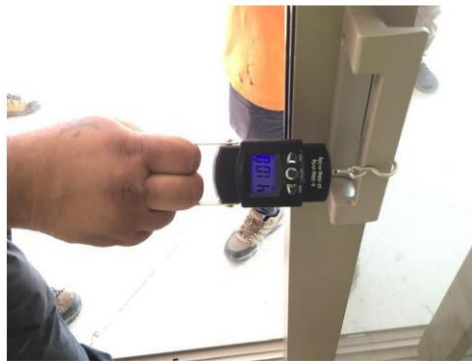
Inoperable SGD.

Fig 20 :Sliding Glass Door Operability Pull Test Using a Handheld Force Gauge, Showing an Opening Force of About 41.00 Lb. (Above the 40 Lb. Acceptance Criterion)
