From Field Observations to Verified Closeout: An Inspection-to-Closure Method for Architectural QA/QC in High-Rise Construction

This paper presents an anonymized coastal Florida high-rise case study built from six third-party architectural inspection reports with photographs and a consolidated issue log. Within this dataset, late-stage architectural findings are disproportionately concentrated at system interfaces rather than in the middle of isolated components. The observed issues are not limited to waterproofing. They repeatedly fall into three operational risk families that shape closeout outcomes:

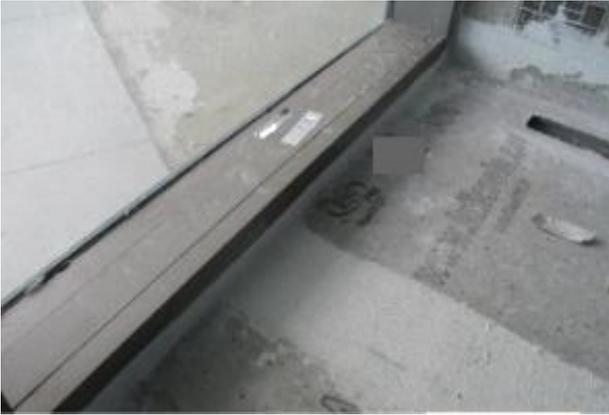
Field signature: The reports identify multiple opening and wet-area conditions described as non-compliant with the permit drawings. For balcony sliding glass doors, the

waterproofing is noted as not extended under the sill/track, even though the architectural detail calls for the waterproofing to run continuously under the sill/track and terminate at the aluminum angle (see figure 1). For master bath shower storefront sills, the reports note that the required “step” is not provided and the water-resistant membrane (pan) is not extended over the storefront sill, even though the architectural detail calls for the step and for the pan to extend over the sill and terminate at a continuous aluminum angle. This condition is illustrated by the intended step-and-pan termination detail and a representative field condition (see Figures 2–3). In addition, some master bathroom areas are documented with the waterproofing/liner not continuous and not turned up the vertical wall in portions of the wet-area build, which the reports flag for correction before tile and wall finishes conceal the condition.

Fig 3: De-Identified Field Photo Showing Missing Step And Pan Termination At The Shower Storefront Sill Prior To Concealment

Verification target: A continuous water-control layer exists through the low-edge interface, and the threshold transition is built so incidental water is kept on the wet side and directed away from concealed substrates. Closure evidence should be objective and visual, documenting the rebuilt condition at the critical interface before and after completion.

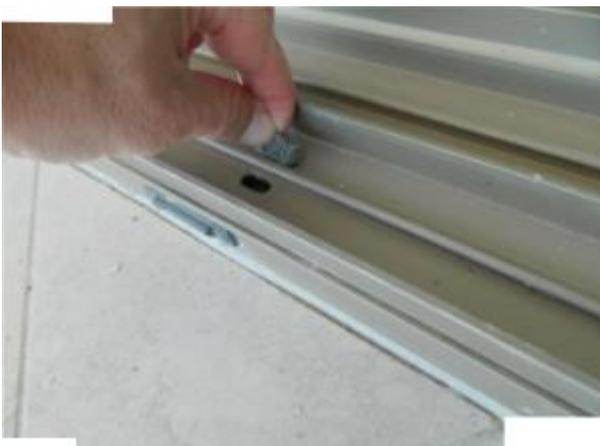
Field signature: The reports document sliding glass door track drainage issues where the weep holes are observed clogged with debris. The reports describe this as a condition that prevents rainwater from properly draining and call for continuous cleaning of weep holes throughout, indicating that the drainage relief points are present but not functioning due to blockage at the time of inspection.

Fig 4: De-Identified Field Photo of a Sliding Glass Door Track Showing a Clogged Weep Hole Being Cleared to Restore Drainage

Risk pathway: A blocked outlet turns a drainage system into a container. When water cannot exit through the designed

weep path, it accumulates in the track pocket and can migrate toward adjacent interfaces [6]. The initiating defect can look minor, but the resulting moisture behavior can affect finishes and concealed cavities beyond the immediate track area.

Verification target: Weeps are open and functioning as intended, and the track assembly is in a condition that permits water to exit rather than remain trapped. Closure evidence should visibly confirm the outlet condition (clear, unobstructed weeps) and the track pocket cleanliness.

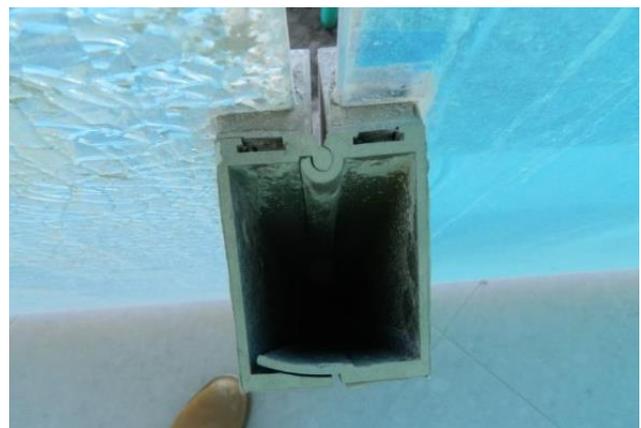
Field signature: The reports document railing installation conditions where the architectural drawings and glass railing shop drawings specify a cover plate over railing posts, but posts are observed without cover plates. The reports explicitly note that the top of the hollow posts remains open, allowing rainwater intrusion into the posts, and recommend installing covers as quickly as possible to avoid leaving the post interior exposed. The open-post condition creates active water entry and internal collection, not merely a cosmetic omission.

Risk pathway: Open hollow posts allow water to enter and remain inside the cavity. Trapped internal moisture accelerates corrosion mechanisms from within, degrades base connections over time, and can create staining or leakage at penetrations [26], [27]. The issue is durability-driven and can persist silently even when exterior surfaces appear acceptable.

Fig 5: De-identified photo of a hollow metal railing post showing the open top condition (no cap/cover plate)

Verification target: Posts are closed in a durable manner so water cannot enter the cavity, and the closure is permanent rather than temporary. Closure evidence should document

the completed post condition in a way that clearly demonstrates the cavity is no longer exposed.

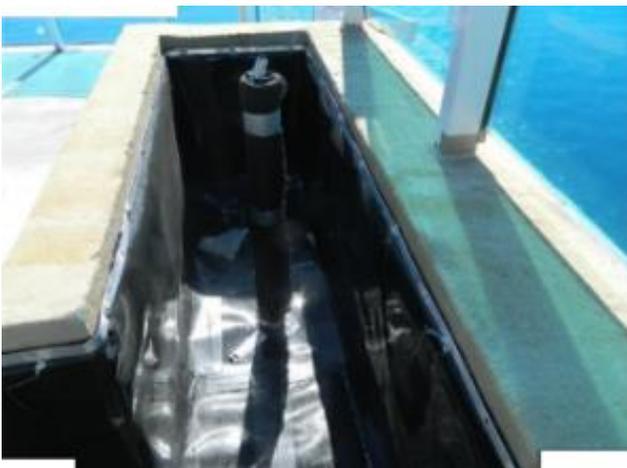
Field signature: The reports document planter waterproofing conditions described as not in compliance with the architectural planter detail. The detail requires the drainage board (a rigid sheet that creates a drainage space against the wall) and root barrier (a protective sheet that resists root penetration) to be installed up to the full height of the planter wall. The same detail calls for a flashing condition at the top of the wall, but the reports describe a termination bar (a metal strip used to mechanically fasten a membrane edge) installed in lieu of that flashing approach, with missing fasteners at pre-drilled holes, indicating an incomplete or improperly secured termination condition at a critical edge [23], [24].

Risk pathway: If drainage and protection layers terminate short, water behavior changes at the top zone: hydrostatic pressure (water pressure from standing water) can increase against the liner, and water can migrate behind an incomplete termination boundary [23]. Missing or incomplete edge securement is not cosmetic because the termination must remain restrained to maintain continuity over time, especially in a zone exposed to repeated wetting.

Fig 6: De-Identified Photo of Planter Liner at the Top Termination Zone

Verification target: The termination condition is complete and secured so that the wet zone remains fully contained and protected up to the intended boundary. Closure evidence should document continuity and edge restraint at the termination zone and confirm the intended layer stack is present where required.

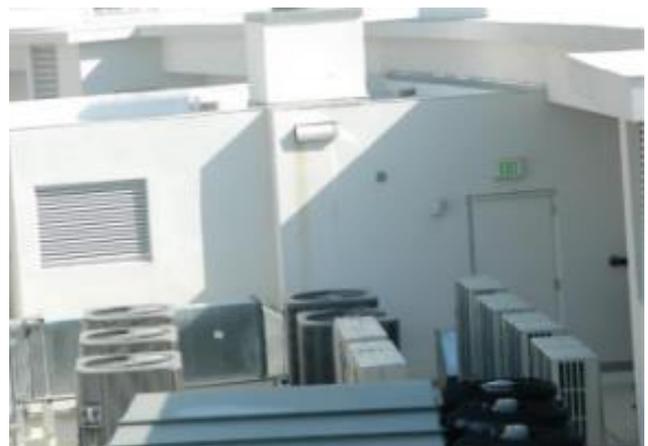
Field signature: The reports document roof drainage control conditions centered on missing collection/discharge elements and incomplete scupper interfaces. Scuppers are wall openings that allow roof runoff to drain out through a parapet. At an upper roof low point, gutters are noted as not observed where the architectural roof detail indicates they should be provided. At stair roofs, gutters and downspouts are noted as not observed at scupper locations, and the reports also record surface stains consistent with ponding at and around scupper openings (indicating insufficient slope at the interface). In addition, the reports document gaps around the perimeter of scuppers that allow rainwater to penetrate at the opening and stain the wall surface directly below, indicating uncontrolled discharge and incomplete edge sealing at the scupper interface.

Fig 7: De-Identified Stair Roof View Showing Scupper Discharge Area Without Gutters/Downspouts At The Parapet Interface

Risk pathway: When roof runoff is not captured and directed, water remains in contact with vulnerable interfaces longer than intended, increasing the probability of leakage at terminations and penetrations [23], [24], [25]. Uncontrolled discharge can repeatedly wet wall assemblies, stain finishes, and drive moisture into joints not designed for persistent flow. Scuppers are especially sensitive because they concentrate multiple transitions into a small opening.

Verification target: Runoff control is complete and continuous at the drainage interface so water is collected and discharged through the intended path, not across unprotected surfaces. Closure evidence should clearly show the completed discharge interface condition and the absence of obvious uncontrolled flow indicators at the scupper edge.

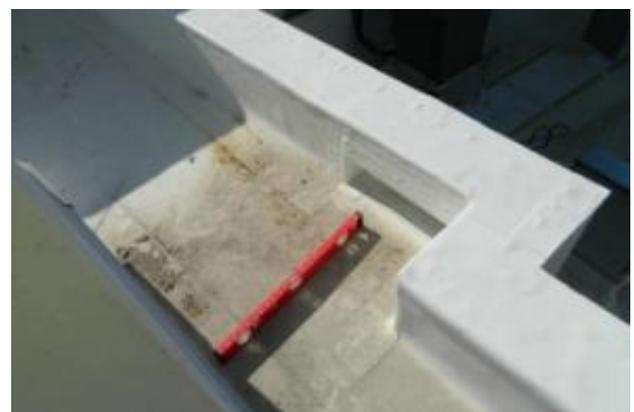
Fig 8: De-Identified Close-Up at a Scupper Opening Showing Staining/Ponding Indicators Consistent with Insufficient Slope at the Drainage Interface

Roof drainage geometry correction (slope rebuilt, membrane reinstated). Where roof drainage performance depended on geometry and the substrate had inadequate slope, the corrective action was structural-to-waterproofing sequencing, not surface patching. The project removed the roof membrane locally, corrected the slope by grinding/reshaping the slab to achieve positive drainage, and then reinstalled the roof membrane system over the corrected substrate [22], [23]. This method closes the root problem (water staying in place) rather than merely covering symptoms.

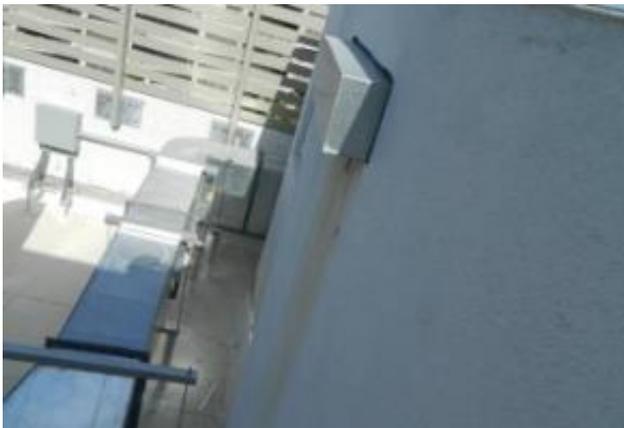
Fig 9: De-Identified Photo Showing an Unsealed Gap at the Scupper Perimeter, Creating a Leakage Path That Stains the Wall Surface Below During Rain Events

Scupper interface sealing and discharge control. At wall-drain openings (scuppers), two physical controls were treated as essential: a sealed perimeter interface and controlled discharge [23], [24]. The project completed perimeter sealing at the opening interface, so discharge occurs through the intended path, not through edge gaps. Where discharge control elements were required, the missing components were installed so water exits the wall opening in a controlled way rather than washing down finished surfaces. Closure was confirmed after the interface was physically complete and re-checked.

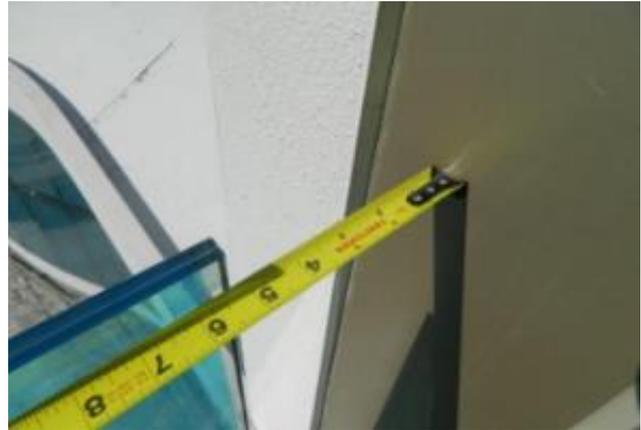
Field signature: The reports document a guard/glass condition where the measured gap between the glass guard panel and the adjacent wall is 5-1/4 inches and is identified as not acceptable relative to the maximum opening limitation used for guards [3]. The observation is presented as a

dimensional compliance issue, not a subjective finish concern.

Fig 10: De-Identified Field Measurement Showing a Guard/Glass-to-Wall Gap Exceeding the 4-in. Maximum Opening Criterion used for Guards

Risk pathway: Guard opening limits exist because the hazard is physical and immediate. When an opening exceeds the allowable dimension, the guard may no longer provide the intended fall-prevention performance for children [3]. This is a compliance trigger because it is evaluated by measurement, and it typically cannot be “interpreted away” during closeout.

For dimensional guard-opening compliance, the closure action was direct: the nonconforming glass panel was replaced with the correct panel, and the final gap was verified against the 4-inch sphere rule (maximum opening 4 inches) [3]. The project treated the measured opening as the closure evidence, not the replacement activity by itself.

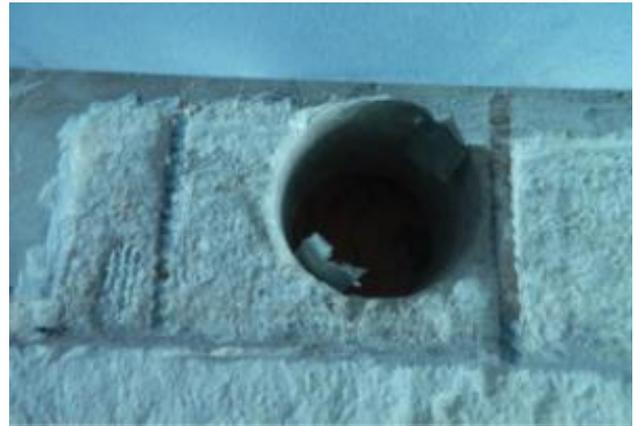
Field signature: The reports document linear drain locations where the slab recess/cutout was ground deeper than intended, including conditions described as approximately 1 inch into the slab, exposing reinforcement. The reports also describe rebar being exposed and in some cases cut during drain cutout work, and they capture follow-up communication indicating the condition requires an engineered review or confirmation rather than a cosmetic patch.

Fig 11: De-Identified Photo Showing an over-Ground Floor/Drain Recess with Exposed Substrate at the Cutout, Indicating a Depth/Geometry Condition Requiring Controlled Repair Before Reinstating the Wet-Area Build-Up

Risk pathway: This is a coordination failure between architectural finish geometry, plumbing requirements, and structural limits. When the drain pocket is over-cut, the issue is not confined to the shower [29]. It can affect slab capacity, corrosion risk at exposed steel, and the long-term durability of the wet-area edge [29]. It also creates closeout uncertainty because the “fix” must be verifiable and acceptable to the project’s engineering requirements, not merely visually covered.

Verification target: The drain pocket depth and geometry must be within the allowable limits for the slab and must not leave reinforcement in a compromised condition [29]. Closure evidence should document the final repaired condition in a way that clearly demonstrates the interface is structurally acceptable and durable in a wet environment (objective confirmation, not visual concealment).

Reinforcement exposure at drain cutouts (repair under structural review). Where reinforcement was exposed at linear drain cutouts due to over-grinding, the project treated closure as a durability and structural interface repair, not a cosmetic cover. The closure method included applying a zinc-rich protective coating to the exposed steel before rebuilding the assembly with a new mud bed and then reinstating the waterproofing and tile system [18], [20], [29]. Importantly, this repair approach was reviewed with the project's structural engineer, and the work proceeded after no-objection confirmation [29]. Closure was confirmed after the repaired build-up and finish system were reinstated.

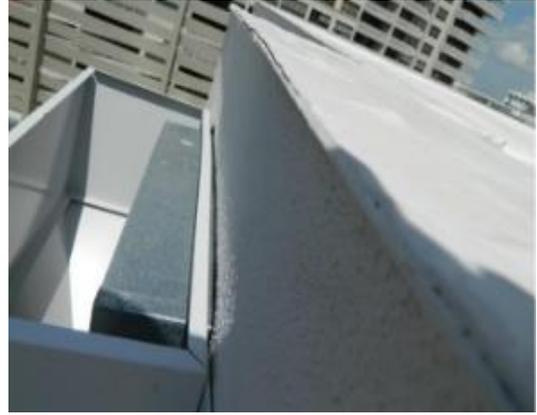
Fig 15: De-Identified Stair-Roof Scupper Discharge Condition after Corrective Work, Showing Added Gutter/Discharge Element to Capture Runoff and Prevent Wall Wetting at the Scupper Interface (Verified During Closeout Re-Check)
