From Field Observations to Verified Closeout: An Inspection-to-Closure Method for Architectural QA/QC in High-Rise Construction

This paper presents an anonymized coastal Florida high-rise case study built from six third-party architectural inspection reports with photographs and a consolidated issue log. Within this dataset, late-stage architectural findings are disproportionately concentrated at system interfaces rather than in the middle of isolated components. The observed issues are not limited to waterproofing. They repeatedly fall into three operational risk families that shape closeout outcomes:

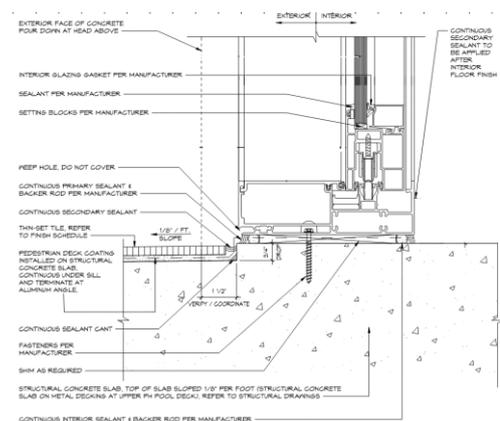
waterproofing is noted as not extended under the sill/track, even though the architectural detail calls for the waterproofing to run continuously under the sill/track and terminate at the aluminum angle (see figure 1). For master bath shower storefront sills, the reports note that the required “step” is not provided and the water-resistant membrane (pan) is not extended over the storefront sill, even though the architectural detail calls for the step and for the pan to extend over the sill and terminate at a continuous aluminum angle. This condition is illustrated by the intended step-and-pan termination detail and a representative field condition (see Figures 2–3). In addition, some master bathroom areas are documented with the waterproofing/liner not continuous and not turned up the vertical wall in portions of the wet-area build, which the reports flag for correction before tile and wall finishes conceal the condition.

Risk pathway: Openings and wet areas are not expected to stay perfectly dry. They are expected to manage incidental water through continuity and positive drainage [6], [18]. When the water-control layer is interrupted at the low edge, water can migrate behind finishes through gravity and capillary action. Once moisture is in concealed zones, the scope typically expands into selective removal, rebuild, and re-verification at an interface that is already schedule-sensitive late in the project.

Fig 1: De-identified sliding glass door sill detail showing continuous waterproofing under the track and termination at the aluminum angle.

Verification target: A continuous water-control layer exists through the low-edge interface, and the threshold transition is built so incidental water is kept on the wet side and directed away from concealed substrates. Closure evidence should be objective and visual, documenting the rebuilt condition at the critical interface before and after completion.

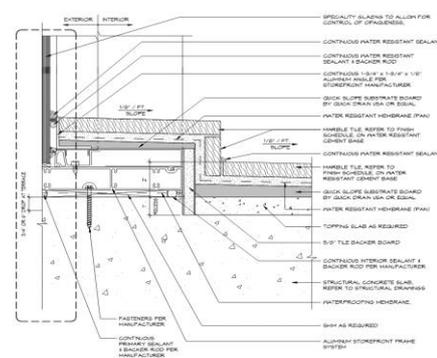
Fig 2: De-identified Shower Storefront Sill Detail Showing Required Step and Pan Termination over the Sill at a Continuous Aluminum Angle

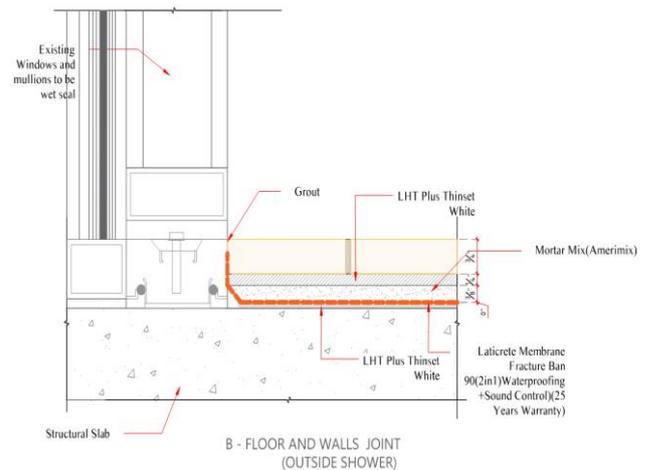
Detail note (Figure 12): The section depicts a continuous waterproofing layer applied over the structural slab and turned up at the wall to form a sealed “tub” at the floor-to-wall transition. This turn-up matters because surface finishes are not watertight; water can migrate through grout joints and the setting bed [18], [19]. Above the waterproofing, the detail shows the typical finish build-up: a bond coat (thinset, a cementitious adhesive layer), a mortar bed (a thicker leveling/support layer), and tile with grout at the surface [18], [19]. Where a crack-isolation layer is specified, it should comply with ANSI A118.12 [21]. The controlling intent is straightforward: finishes may get wet, but the waterproofing layer must remain continuous through edges and transitions so that wetness does not become hidden damage.

Fig 12: De-Identified Floor-To-Wall Transition Detail Showing Continuous Waterproofing Turned Up at the Wall Beneath the Tile Assembly to Maintain Wet-Area Containment at the Joint

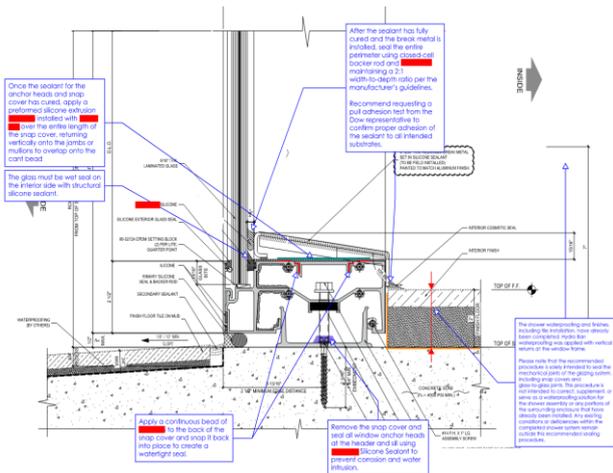
A third alignment case addresses the “step” condition at a shower/storefront sill transition. The issue was treated as high priority because the step and termination geometry govern whether water is kept within the wet zone and directed back to the intended drainage path. The project escalated the observation through internal review and the waterproofing consultant, and the consultant issued a final field detail that resolved the interface explicitly. The glazing team was then directed to coordinate and fabricate brake metal (bent sheet-metal trim used to cover, protect, and visually finish an edge/joint) at the sill and header so the elevation remained consistent while the waterproofing termination and protection logic remained correct [24]. The team field-verified dimensions released the brake metal for fabrication and executed the installation. Closure was declared only after the consultant inspected the finished condition and confirmed conformance to the issued detail, and after the architectural reference was aligned to the verified field condition to eliminate repeat flags driven by outdated details.

Detail note (Figure 13): This detail clearly separates two functions that are often confused in the field: waterproofing of the wet assembly versus sealing of the frame perimeter joints at a sill/track interface. The callouts focus on the joint system where fasteners, snap covers, and frame components create multiple micro-paths for water entry. The detail calls for continuous sealant at critical interfaces and around connection points, with backer rod (a compressible foam rod that controls sealant depth and shape) where required to achieve a stable seal profile [9], [10], [16], [17]. It also references snap covers (clip-on cover pieces that conceal fasteners/anchors) and indicates sealing at those interfaces, so the sill/track joint does not behave like an “open seam.” The key point is practical: even if the wet-area waterproofing is correct behind finishes, an unsealed sill/track perimeter joint can still leak unless the joint is sealed as a system [6], [17].

Fig 13: De-Identified Sill/Track Joint Sealing Detail Showing Continuous Sealant and Backer-Rod Placement at Frame Interfaces to Control Water Intrusion at the Perimeter Joint

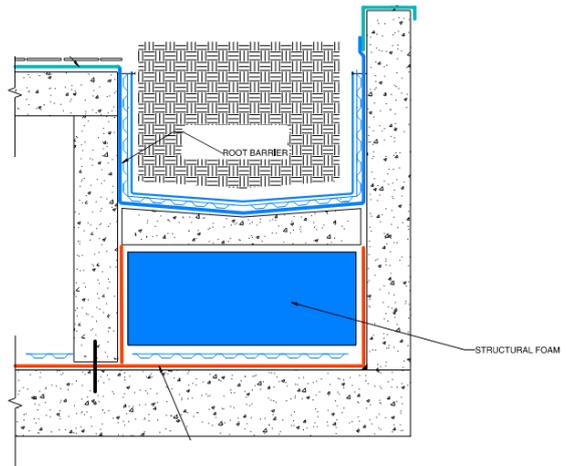
The same alignment logic applied to exterior wet assemblies such as planters. The observation questioned termination height and edge detailing relative to the architectural detail, but the installed assembly followed the approved system approach reviewed by the consultant, including application continuity and acceptance based on inspection. The project closed the item by anchoring the governing basis to the approved system and acceptance record and then aligning the architectural reference detail to the verified condition, preventing a recurring mismatch between “what is built” and “what the drawings imply.”

Detail note (Figure 14): The planter section shows why planters behave like “small roofs” built inside the building. They require a continuous waterproofing liner, a protection/drainage layer, and a root barrier so moisture and roots do not attack the structure or finishes [23]. The detail depicts the liner running across the base and up the planter walls, with drainage and root-protection components carried to the required height so water can drain without pressurizing the wall. The top termination is the most sensitive edge: incomplete terminations (short liner height, missing securement, or incorrect termination hardware) can turn controlled drainage into staining or leakage [23], [24]. The technical theme is continuity, not patching. The liner must remain intact through transitions and terminations to control where water goes.

Fig 14: De-Identified Planter Waterproofing Section Illustrating the Liner Turn-Up With Root Barrier and Drainage/Protection Layers, Highlighting the Termination Zone Where Continuity and Secure Edge Restraint Control Leakage Risk

Verification target: The termination condition is complete and secured so that the wet zone remains fully contained and protected up to the intended boundary. Closure evidence should document continuity and edge restraint at the termination zone and confirm the intended layer stack is present where required.
